**NOTICE TO CONTRACTORS  
INVITATION TO BID  
ASBESTOS ABATEMENT OF BUILDINGS**

**Demolition Property Addresses: 2325 Madison Avenue, Ogden UT 84401**

**A LIMITED  
ASBESTOS SURVEY AND ASSESSMENT  
FOR THE  
ASPEN CARE CENTER  
ASSISTED LIVING FACILITY  
2325 Madison Ave  
Ogden, UT 84401**

**November 25, 2023**

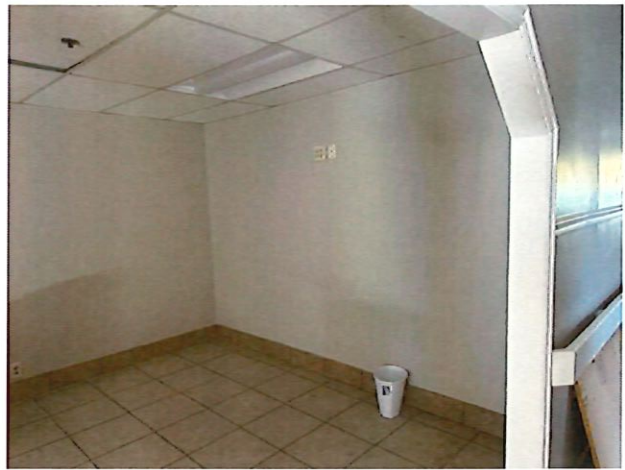
Material	Material Location	Quantity	Lab Result (%/Type)	Assessment
Wall System Texturing (Surfacing)  See Photo #2	Throughout Building (Various Locations)	~32,000 ft <sup>2</sup>	4% Chrysotile	Undamaged
Rolled Vinyl Flooring (Miscellaneous)  See Photo #3	Storage Closets	~110 ft <sup>2</sup>	17 % Chrysotile	Undamaged

**PHOTO 2: Asbestos Containing Wall System (Surfacing)**

Asbestos-containing materials were identified in the building. See Executive Summary for details. This material should be removed prior to disturbance.

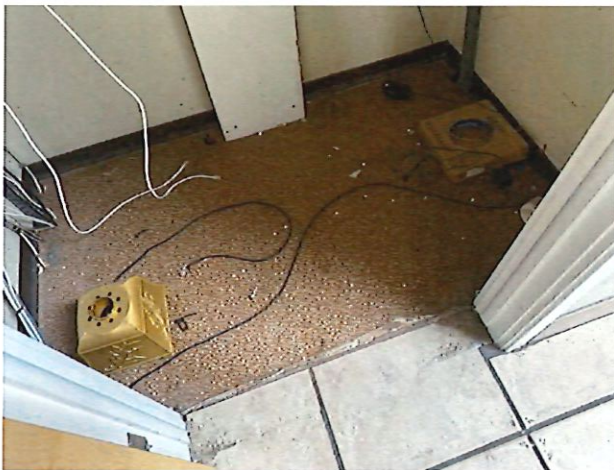
**PHOTO 3: Asbestos Containing Rolled Vinyl Flooring**

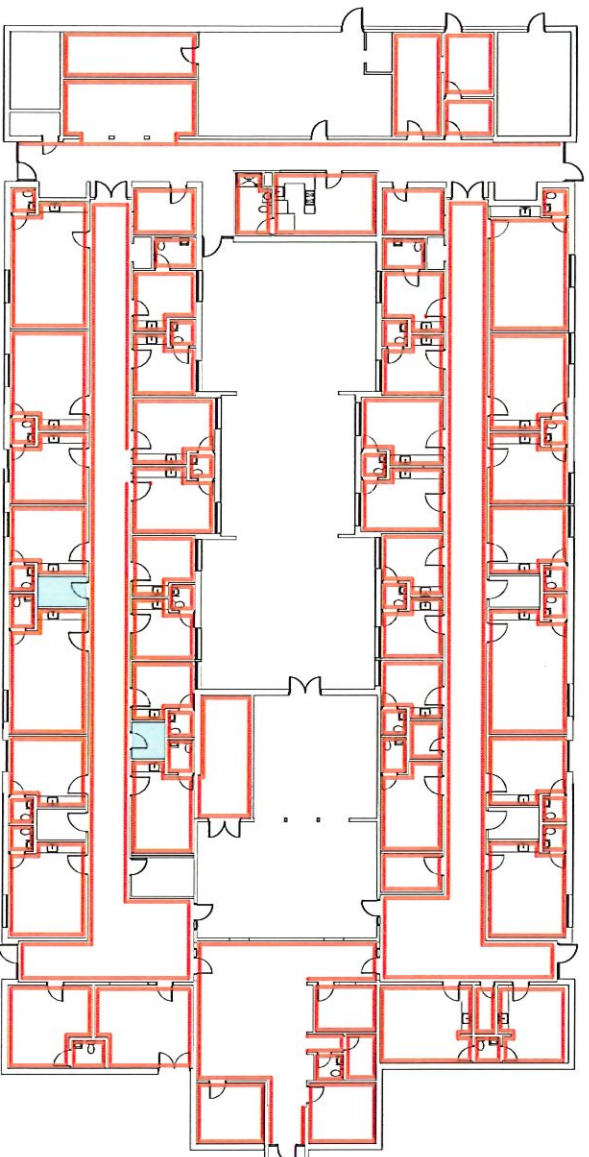
ACM LOCATIONS  
FIRST FLOOR

ASBESTOS CONTAINING WALL SYSTEM SURFACING MATERIAL  
ASBESTOS CONTAINING ROLLED VINYL FLOORING
